# City of St. Cloud – Whitney Park

## Dam Removal & Streambank Restoration

Dam Removal &  
Streambank Restoration

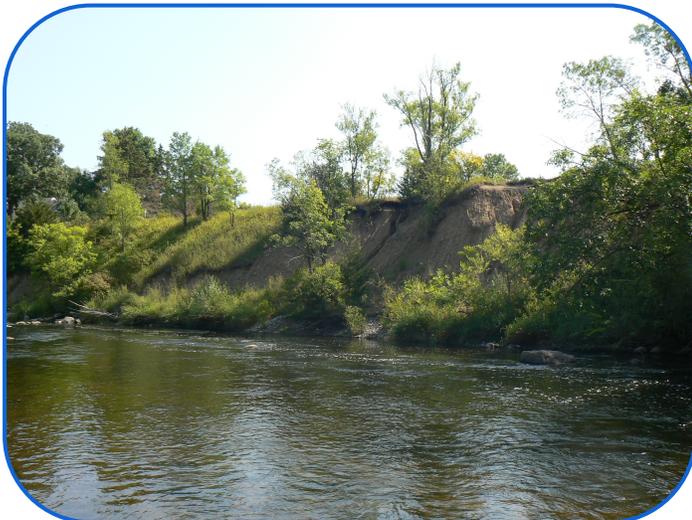
Before Project – Failing Slope

**Project Description:** The Whitney Park site on the Sauk River has a severely eroded outside bank. This steep slope along 450 feet of streambank has areas that are up to 30 feet in elevation. The City of St. Cloud approached the Stearns County SWCD for technical and financial assistance to address the problem. The SWCD, along with the West Central Technical Service Area, designed a low impact approach to stabilizing the streambank. This involves using field stone rock for stream barbs, and toe wood. In addition, when the slope is re-graded, native grasses and wildflowers will be seeded and planted from plugs. Trees and shrubs will also be planted from potted stock. The entire site will be hydro mulched or covered with erosion control blanket to ensure stabilization. As a part of the planning process, the low head dam in the river upstream of the slope failure was determined to be causing the problem and is scheduled to be removed.

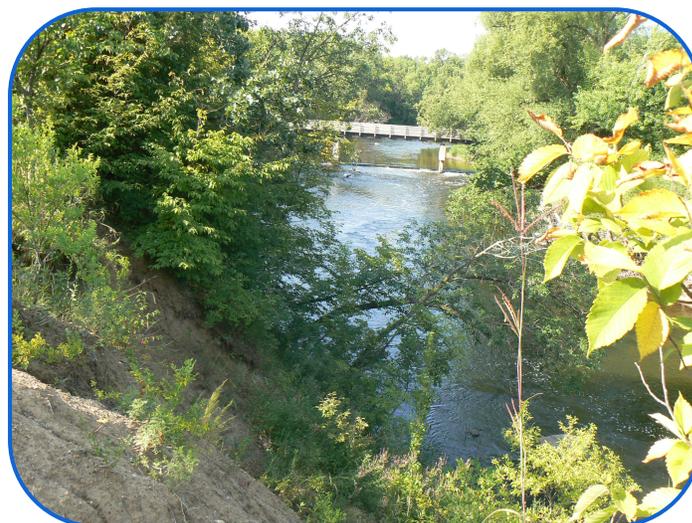
Before Project – Habitat Degradation

(Dam In Background)

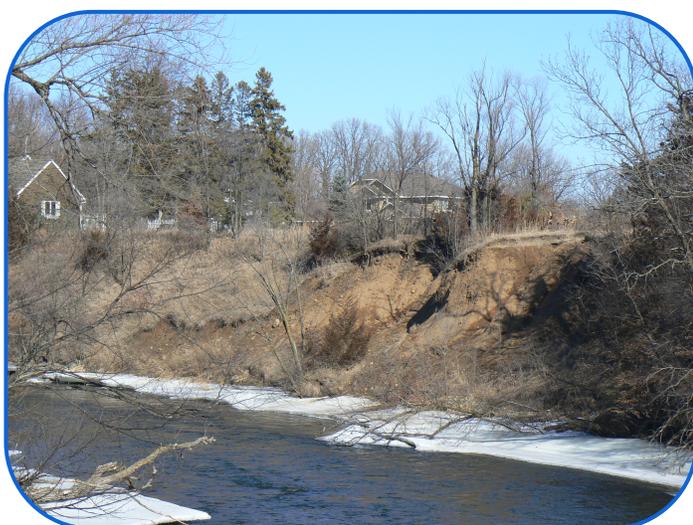
Before Project – Failing Slope
